Stormwater Study Area 'B'

Town of Kure Beach

April 8, 2020

Subject: Stormwater Study – Area 'B'

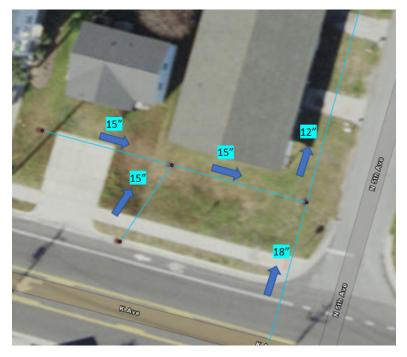
LDSI's team identified five specific throttle points that are causing restrictions to performance within the drainage network. As seen in Figure E, the inlet box at the corner of K Ave & N 5th Ave has a 15" pipe and an 18" pipe leading into it with only a 12" pipe leading out. However, the H&H model does not show this specific run of pipes as being surcharged at any point within a 25-year storm event. It is likely that the 15" pipe section running into it is larger than it needs to be for the watershed that it is draining. Additionally, the 18" pipe leading into the structure is only a 12" pipe at the other end. This indicates that either the pipe changes diameters at some point along this run, or there are additional pipes feeding into the 18" pipe. Without performing a camera inspection, it was not possible to determine so when modeling the system, the pipe run was treated as a single pipe. The 12" end of the pipe is located in one of the "homemade" style inlet boxes as seen in Figure N.

Figure E: A Choke Point By the Intersection of K Ave & N 5th Ave

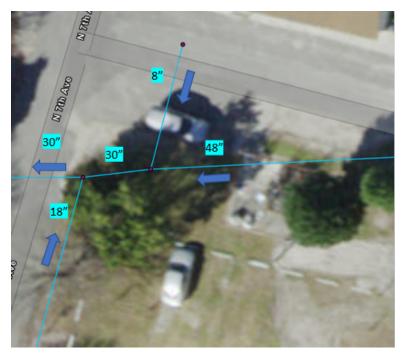
The next choke point of concern is behind the fire station on K Ave as seen in Figure F. The point is located upstream of the outlet for the drainage network. A 48" pipe and an 8" pipe feed into a 30" pipe. That 30" pipe has an additional 18" pipe run into it prior to discharging. This configuration significantly reduces the ability of the 48" pipe and under full conditions would cause significant tailwater interferences. However, the H&H model revealed that the interconnected pond network allows for a great deal of stormwater storage and significantly attenuates the volume of water that must be discharged from the network at any given time. The model showed that this junction also does not operate under a surcharged condition during a 25-year storm event. When analyzing severe "worst case" storm events, it was found that the existing network will use the ponds to attenuate stormwater and relieve pressure that would have otherwise been on the lower run of the network. This is advantageous in that it means the configuration shown in Figure X is functional within the current network. However, it poses a potential problem in that a large storm event would cause flooding within the ponded areas prior to reaching the system's maximum outflow capacity.

Figure F: A Choke Point Behind the Fire Station on K Ave

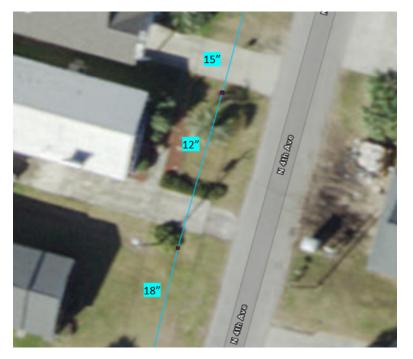
A throttle point, as seen in Figure G, was found on the West side of N 4th Ave in between L Ave & M Ave. This throttle point consisted of an 18" pipe running into a 12" pipe and then into a 15" pipe. This reduction in capcity significantly inhibits the performance of the drainage network. The H&H model revealed that this pipe run, along with portions upstream of it, operate under surcharged conditions during a 2-year storm event.

Figure G: A Throttle Point Along N $4^{\rm th}$ Ave Between L Ave & M Ave

- Analyze the sediment storage capacity of the ponds within the drainage network
- Perform an alternatives analysis for Area B
- Perform an analysis of the existing drainage network (and alternatives) in Area A
- Perform an ordinance audit and assess options to lower the drainage volume and network demand
- Remove the 18" pipe seen in Figure L
- Perform vacuum maintenance on the existing drainage network to remove sediment
- Replace the 12" pipe seen in Figure G
- Perform micro-grading near Structure 9999 to ensure drainage and prevent surface ponding

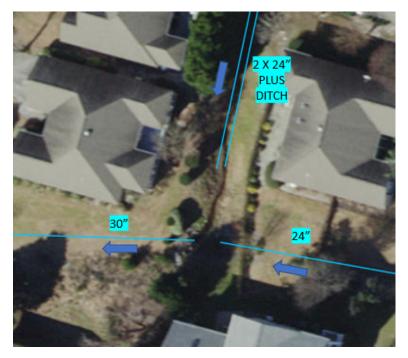
A significant choke point was identified between N 5th Ave and Settler's Ln as seen in Figure H. Two 24" pipes below a ditch and an additional 24" pipe all run into a single 30" pipe. The capacity of the three 24" pipes far exceeds the capacity of a single 30" pipe. However, it was found that the quantity of water routed through the two 24" pipes is significantly attenuated by the pond network that it drains. Because the upstream ponds store such a large volume of water and only drain through the two 24" pipes, the outflow is throttled by an inlet boundary condition. Due to this, the choke point identified in Figure H does not cause any surcharging within a 25-year storm event.

Figure H: A Choke Point Between N 5th Ave and Settler's Ln

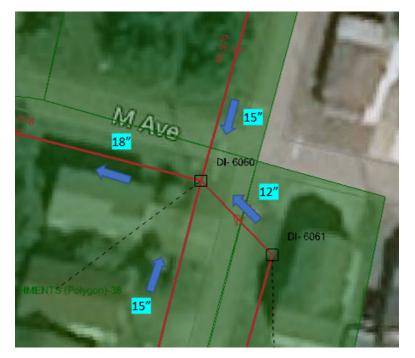
The final significant choke point found during the analysis is located at the intersection of M Ave and N 5th Ave as seen in Figure I. Two 15" pipes along with a 12" pipe feed into a single 18" pipe. The H&H model reveled that during a 25-year storm event the quanitiy of water passing through these pipes is not enough to cause a surcharge condition.

Figure I: A Choke Point at the Intersection of M Ave and N 4th Ave

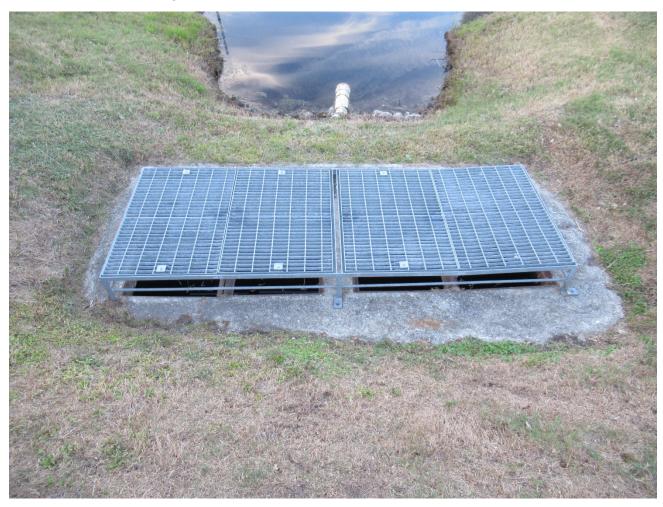
Figure K: Dual Grate Outlet Drain for Pond Network

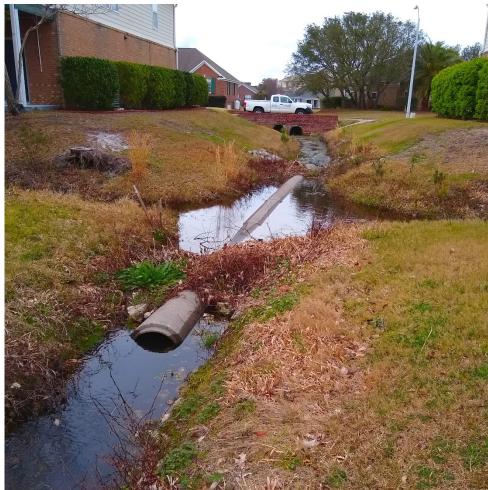
Figure L: 18" Pipe Within Ditch Connecting the Ponds

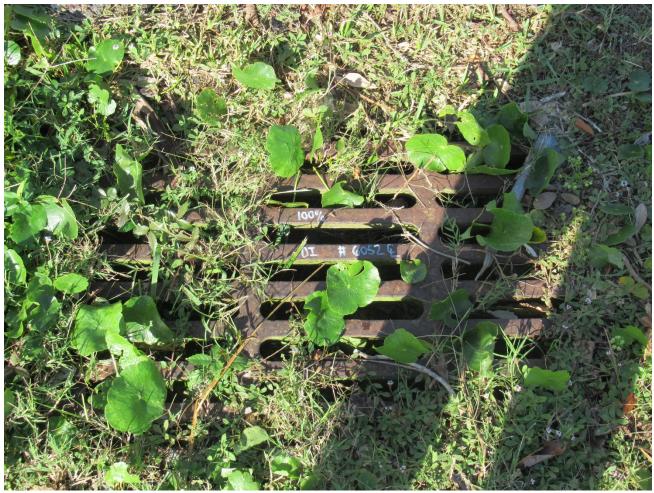
Figure M: Obstructed Inlet Grate

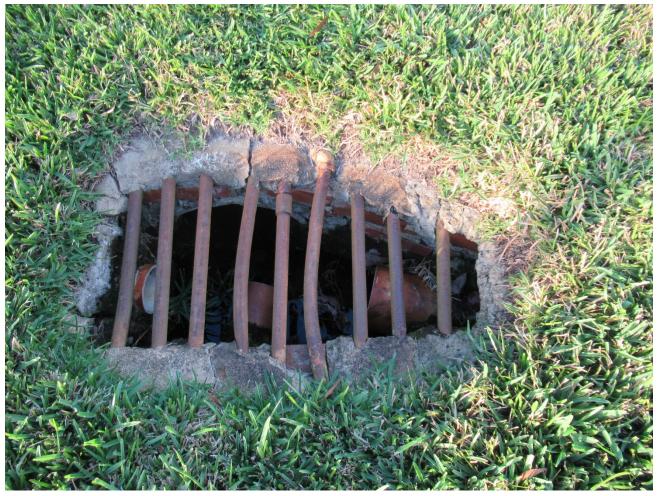
Figure N: "Homemade" Yard Inlet
