Stormwater Study Area 'B'

Town of Kure Beach

April 8, 2020

Subject: Stormwater Study – Area 'B'

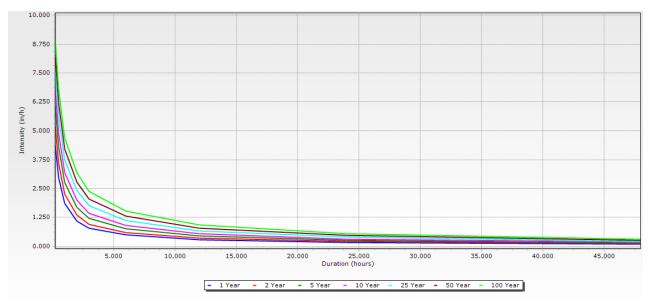
Figure B: The IDF Curve Used to Generate Storm Events within the H&H Model

Historic rainfall data for Kure Beach was determined via NOAA's Atlas 14 tool. This rainfall data was used to generate an Intensity Duration Frequency (IDF) chart (Figure B) that would govern the storms simulated within the hydrologic model. The IDF chart was input into the model to simulate a variety of conditions ranging from a 2-yr storm to a 25-yr storm in order to assess the performance of the existing drainage network. Watersheds were individually delineated for each catchment leading into the stormwater system so that a comprehensive analysis could be conducted of each section of the network. As a part of the analysis, rainfall area, percent impervious surface, composite time of concentration, and type of surface flow experienced during a storm event were determined for model inputs. These values were used when calibrating the stormwater model to determine at which points during a storm event any given section of the pipe network would be under maximum load. Determining the maximum load that the network might experience during a storm allows deficiencies in the network to be predicted and analyzed. This also allows for any tailwater effects that might be caused upstream of that section to be determined. The ponds within the network were modeled as interconnected surface water bodies so that the wholistic effects of storage, stormwater attenuation, flood routing, and tailwater could be analyzed. The available maximum volume of the ponds was determined using LiDAR data as well as cross sections and supplemental information recorded by the survey team.

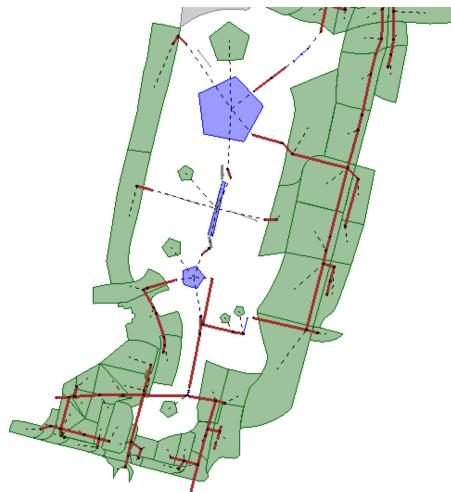
Figure C: A Plan View of the H&H Model Created in CivilStorm

The rainfall runoff data generated by the simulated storms and watershed parameters was input to the model so that the existing network's hydraulic properties could be analyzed. These properties included Hydraulic Grade Line (HGL), Water Surface Elevation (WSE), maximum flow, and maximum velocity. It was found that there are multiple choke points or restrictions within the existing drainage network. This means that there are multiple locations where downstream pipes are smaller than their upstream pipes. Transitioning from a pipe of a larger diameter to one of a smaller diameter severely restricts the quantity of water that can pass through and results in increased tailwater upstream of that pipe. Additionally, there are junction choke points where multiple pipes all lead into a single pipe that is not capable of adequately handling the volume of water that is provided. These have the same effect of reducing the quantity of water that can pass through and increasing the upstream tailwater. In addition to these choke points, there are several pipe runs throughout the network that are installed at a reverse grade. Water flowing through these sections of pipe must travel "uphill" in order to pass through them which is typical of systems in the flat tidal sections of NC's coastal plain. These sections of pipe require a larger head (driving force) for water to flow through them. This increases the tailwater effects on upstream pipes while reducing flow and increasing the likelihood of surface ponding. The stormwater drainage system at Kure Beach is gravity driven so any pipe runs set on a reverse grade inhibit the functionality of the network, and at low volume levels can even result in reverse flow. Several sedimentation restrictions have also been identified within the existing network including multiple clogs and blockages. It was also noted that there is a high level of sediment flux within the network, meaning that sediment washes into the pipes and a portion of that also washes out at the end of the pipes or settles within the ponds. There were multiple severe blockages due to sedimentation, including several surface exposed pipes that became partially or completely filled with soil. Sedimentation reduces the flow capacity within the pipe network by limiting the available area for water to flow through. Additionally, sedimentation will also reduce storage capacity and stormwater attenuation capability of the ponds within the drainage network.

After analyzing the H&H model, LDSI found that multiple pipes operate under surcharged conditions during storm events at recurrence intervals as low as 2 years. The more intense, higher recurrence interval storms caused more pipes to operate under surcharged conditions as seen in Figure D (note that each recurrence interval includes all pipes from the previous intervals). A surcharged pipe condition is a sign that the pipes in place are likely undersized or are inhibited in some way. This could include pipes being installed at a reverse grade, choke/throttle points within the pipe network, or an excess of pipes being drained through a single outlet.
